EFFECTS OF ABNORMAL CONDITIONS ON ACCURACY OF ORIFICE MEASUREMENT

Class # 1100

Thomas B. Morrow, P.E.
Engineering Consultant
8327 Chivalry St.
San Antonio, TX 78254 USA

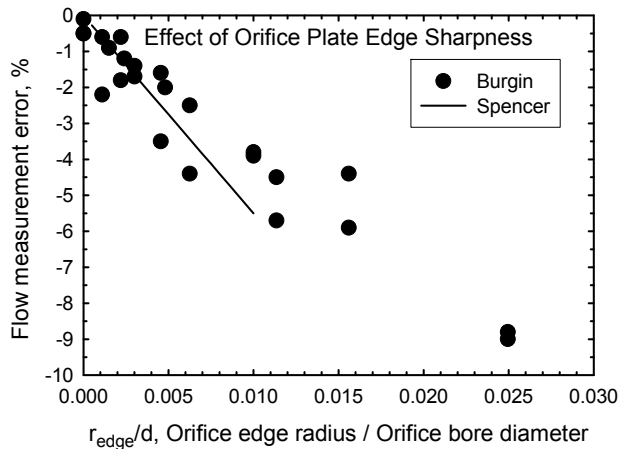
Fig. 2 Measurement error caused by rounding the sharp orifice plate edge.

Burgin presented results for the per cent flow measurement error from tests sponsored by the Gas Measurement Committee during the period from 1925 to 1930. The tests were carried out in air, in 4-inch meter tubes, for three different orifice β ratios. The results are shown in Figure 2 for measurement error as a function of the ratio of the

Spencer reviewed data on the effect of edge sharpness on orifice C_d and recommended an empirical correlation shown as the straight line in Figure 2. Spencer suggested that the ratio of edge radius to bore diameter should not exceed 4×10^{-4} if the effect on C_d is to be limited to less than 0.2%.
